DOT/FAA/CT-85/36

Crash Dynamics Program Transport Seat Performance and Cost Study Benefit Study

October 1986

Final Report

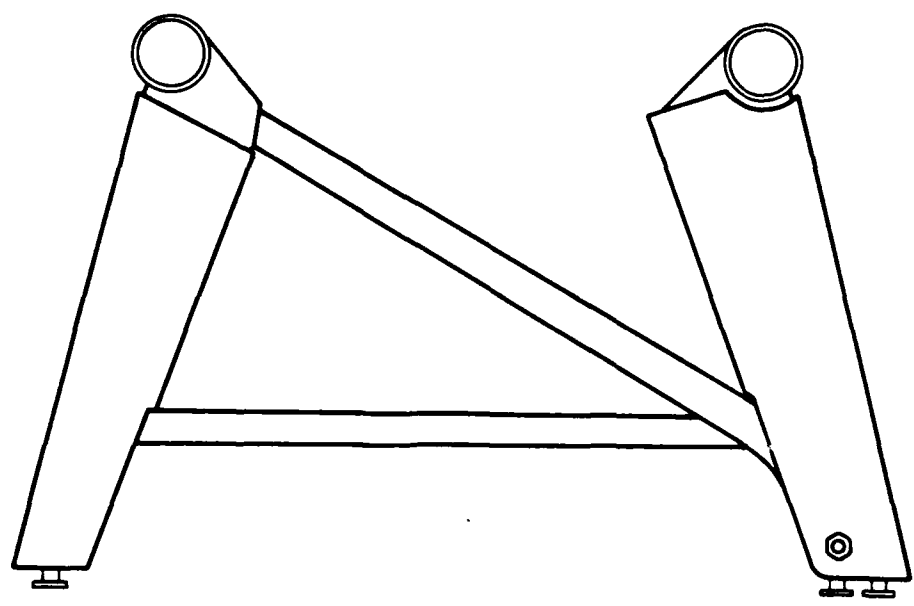
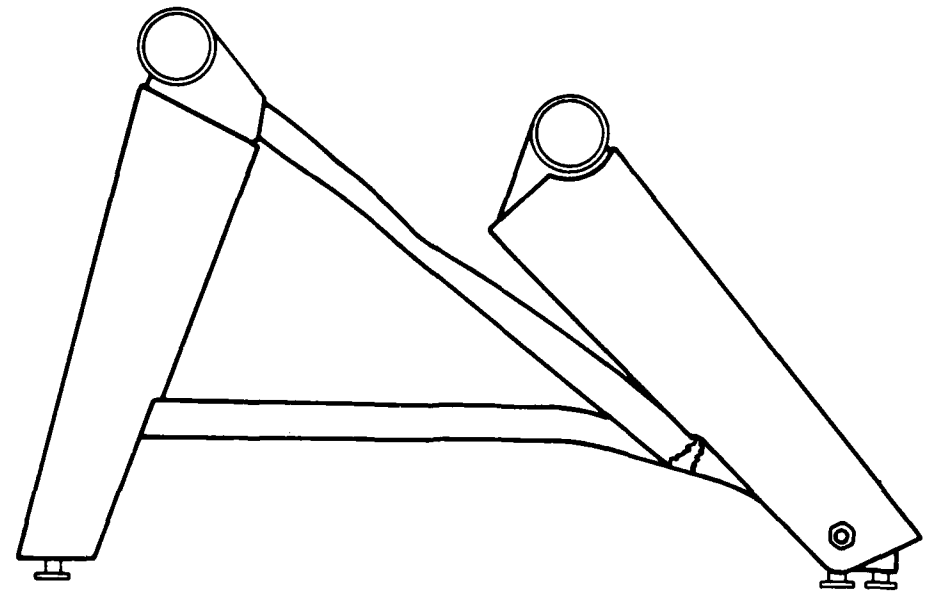
One of the seats used during the 1960's, the Hardman Model 8727, did not have energy-absorbing devices, but its sheet metal construction enhanced its performance under loading conditions. When subjected to a forward test, the sheet metal seat pan crushed and the rear legs rotated about their attachment points (figure 11), allowing the occupant to move forward while the deforming metal absorbed some of the energy.

Figure 11. Leg deformation of the Hardman 8727 seat after forward static test.
